## 木橋（吊り橋）の補修

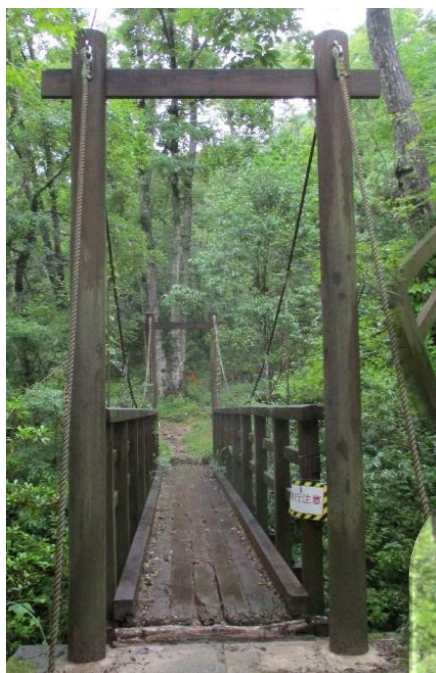
20 (R2) 07.04 床板・手摺の腐食が激しく散策に危険な木橋
